259071  
750  
CUSTOM-HOUSE, NEW ORLEANS.

*Tabular statements of the subsidence of the walls of the custom-house  
at New Orleans, &c.*

FEBRUARY 5, 1855.—Laid on the table, and ordered to be printed.

SUPERINTENDENT'S OFFICE, NEW CUSTOM-HOUSE,  
*New Orleans, December 22, 1854.*

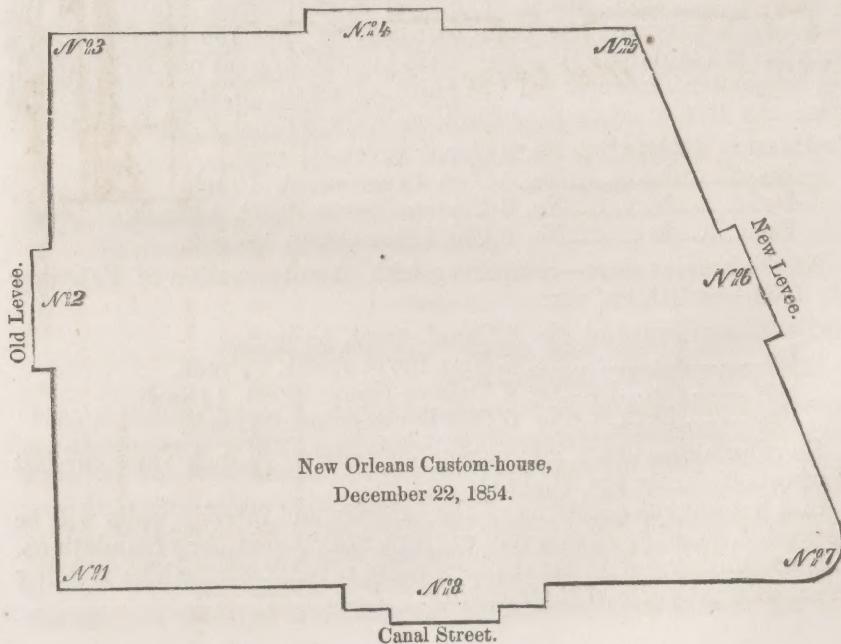
*Plan of reference for above levels; the figures corresponding to the points of observation.*

SIR: I enclose you herewith statements in tabular form, showing the settlements of the foundations of the new custom-house, New Orleans, and the inclination outward of the exterior walls, from which you will perceive that the greatest settlement since December 6, 1851, is  $\frac{797}{1000}$  of a foot, or a little over  $9\frac{1}{2}$  inches; and since February 28, 1854,  $\frac{384}{1000}$  of a foot, or a little more than  $4\frac{1}{2}$  inches. Both points are indicated on the annexed skeleton plan; the latter being No. 3, or the angle of Old Levee and Custom-House street; the former No. 4, or

portico on Custom-House street; and I would remark here, that, as a consequence of this unequal subsidence, the plinth stone (No. 17 of the lithographed elevations) is broken through under the window-jamb, showing the fracture quite distinctly: this stone occurs under the second window on the right of the middle portico on Custom-House street front. In this connexion, I would refer to the state of the great central arches. The depression of their crown has been going on until it now amounts to  $4\frac{1}{16}$  inches, as compared with the keys of the contiguous ranges of groined arches. This effect appears to spring partly from the great subsidence of the centre projections on Custom-House and Canal street fronts, and partly from the tendency of the exterior walls to incline outwards at those points. The impression thus created appears to extend itself, in a greater or less degree, entirely through the central portion of the structure from New Levee to Old Levee front, exhibiting itself on the latter front in the opening of the joints of panel stones under window-sills, and, in general, at all weak points in the direction alluded to, such as the arched openings in partition walls, &c., one of which openings in the second story became fractured to such a degree that I was compelled to take down the arch and rebuild it; the entire tendency showing conclusively the importance of increasing the weight on the foundations of the central portion of the building before adding to the already too great pressure on the foundations of the exterior.

Total.	Since December 6, 1851.	Total.	Since February 28, 1854.
No. 1.....	0.694 of a foot.	No. 1.....	0.314 of a foot.
2.....	0.655 "	2.....	0.313 "
3.....	0.747 "	3.....	0.384 "
4.....	0.797 "	4.....	0.383 "
5.....	0.561 "	5.....	0.284 "
6.....	0.561 "	6.....	0.287 "
7.....	0.382 "	7.....	0.156 "
8.....	0.763 "	8.....	0.350 "
